THESIS

**LASER PEENING FOR MITIGATION OF STRESS
CORROSION CRACKING AT WELDS IN MARINE
ALUMINUM**

Heather R. Mattern

June 2011

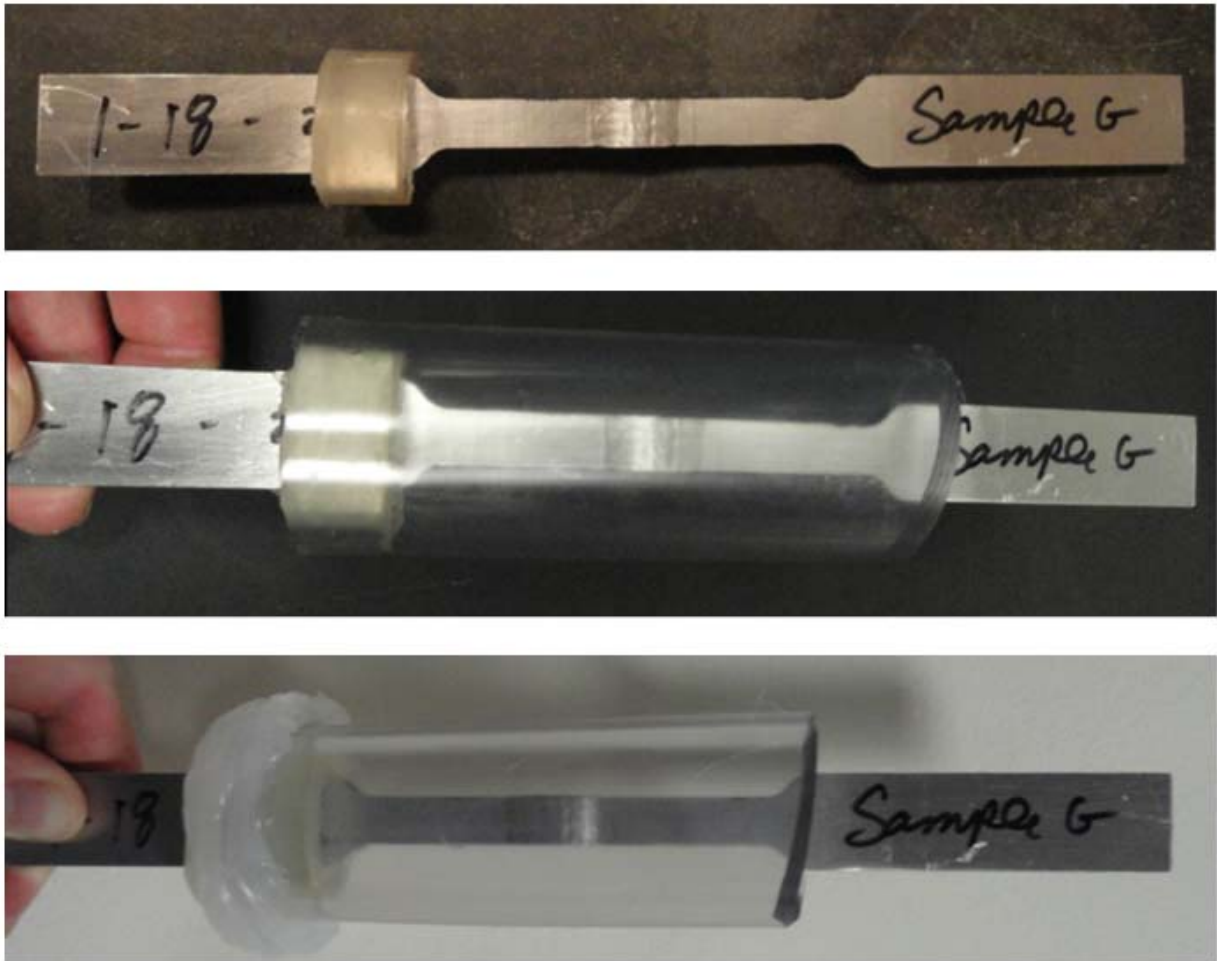
Figure 16. SSRT sample from top: initial securing puck, with Tygon tubing, and with silicone.

A special sample holder was designed for this work to allow intimate contact of the SSRT specimen with the corrosive solution during testing while allowing unconstrained displacement of the load frame (Figure 16).

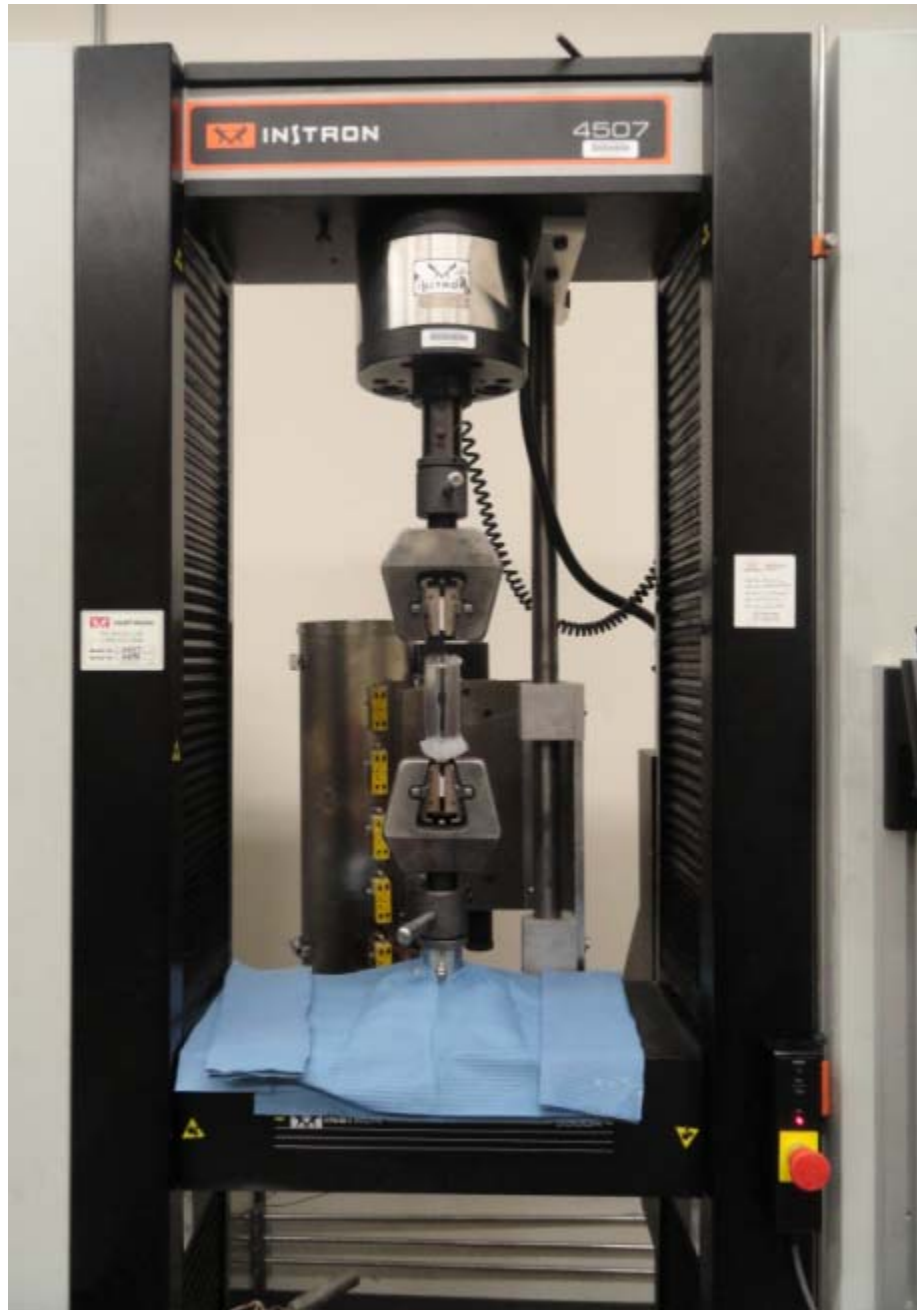
Figure 17. Instron 4507 test frame used in the SSRT testing of laser peened samples.

The SSRT was carried out on an Instron 4507 test frame (Figures 17 and 18). This instrument used an Instron load cell with a load rating of 200 kN static and 100 kN dynamic in both compression and tension, for force measurement and screw-driven, cross-head displacement for strain measurement. The 4507 frame has a testing speed range of 0.001 to 500 mm/min. All stresses and strains were computed as engineering stresses and strains using the original and final dimensions of the specimen. As these tests were concerned primarily with strain to failure, these measurements of stress and strain were deemed sufficient. All tests were performed with a constant extension rate of 50 nm/second. This displacement rate was chosen based upon a desired uniaxial strain rate of 10^{-6} for the geometry of specimen shown in Figure 15. This strain rate is consistent with the work done by Zucchi and Hatamleh [5, 13]. It is also within the parameters set forth in ASTM G 129-00, Standard Practice for Slow Strain Rate Testing to Evaluate the Susceptibility of Metallic Materials to Environmentally Assisted Cracking [19]. It should be noted that this displacement rate only gives a strain rate of 10^{-6} at the start of the test. The strain rate decreases as the specimen becomes longer.

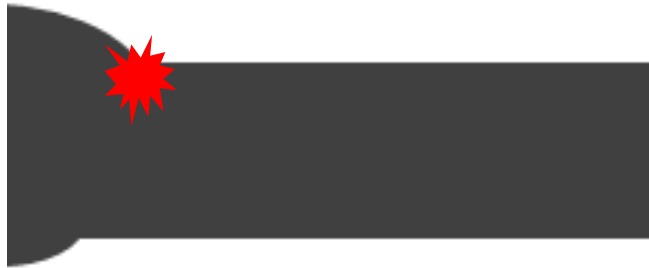
Figure 28. Vickers hardness as a function of position across the weld for the control weld and LP 3-27-2. The red indicator on the below diagram (the base of the HAZ) aligns with the 0 point on the distance axis.

The microhardness data was then gathered across the weld through the HAZ into the base metal using the Vickers Hardness test. Figure 28 compares the microhardness data and the most intense laser peened condition, LP 3-27-2. The control weld displayed a typical hardness profile with a softer area in the weld and into the HAZ. There is only slight increase in hardness in the base metal but a qualitatively large difference in hardness in the welded region and the HAZ. LP appears to even out the hardness profile of the HAZ into the weld, making a more uniform hardness profile throughout the sample.
